PEARL INSPECTION SERVICES

## HOME INSPECTION REPORT

1234 Main Street  
Damascus, OR 97089

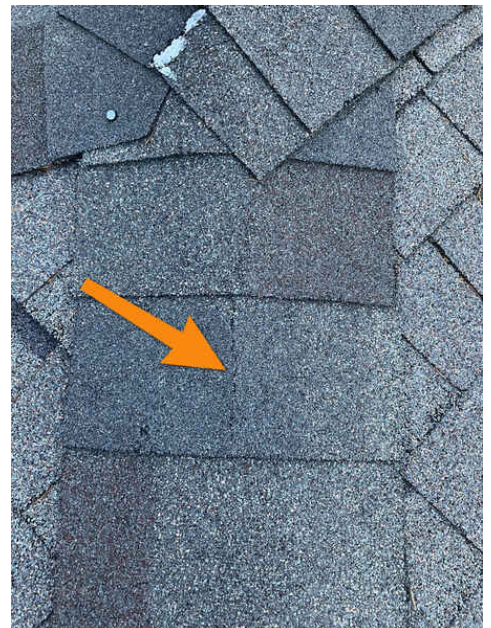
I observed cracked and damaged shingles. Prone to leaking. Correction and further evaluation by a professional roofer is recommended.

Cracked ridge shingles - multiple places

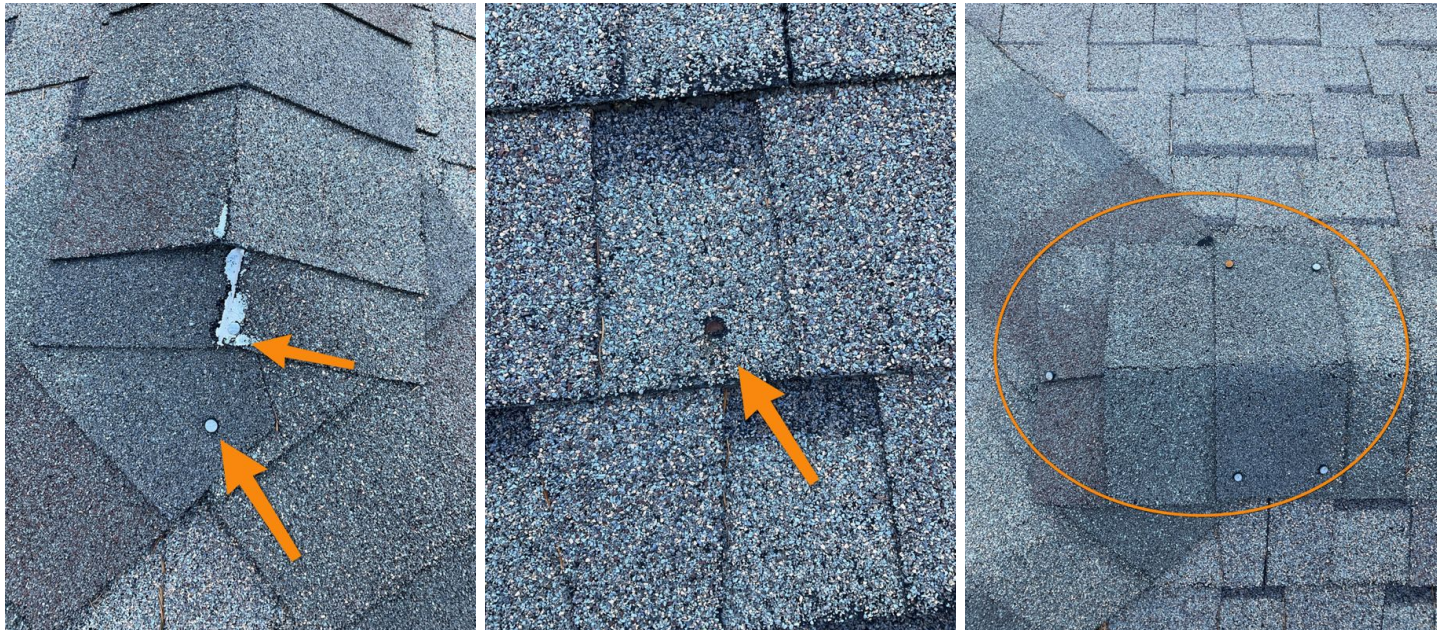
2.1.2 Roof Covering

I observed exposed fasteners at the roof-covering materials. Fasteners should not be exposed. Potential water entry points. Roof could leak. Further evaluation and correction is recommended. Fasteners have gaskets, but should also be sealed with an approved sealer.

Contact a qualified roofing professional.

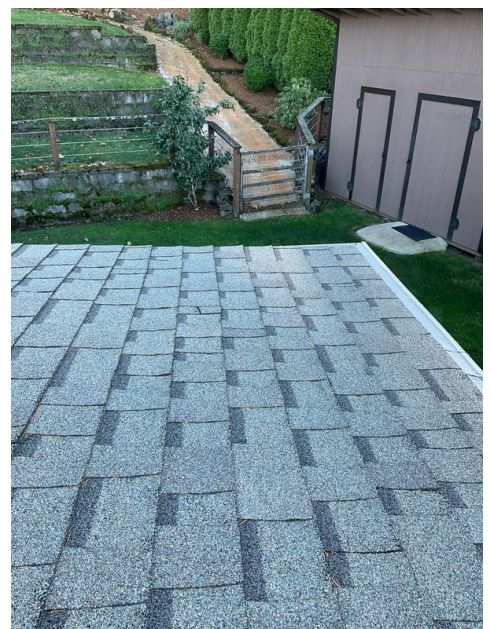
2.1.3 Roof Covering

I observed indications of improperly installed roof-covering materials. This is not according to best practices or common standards. Defect. Prone to water intrusion and roof leaks. Further evaluation and correction by a roofer is recommended.

Contact a qualified roofing professional.

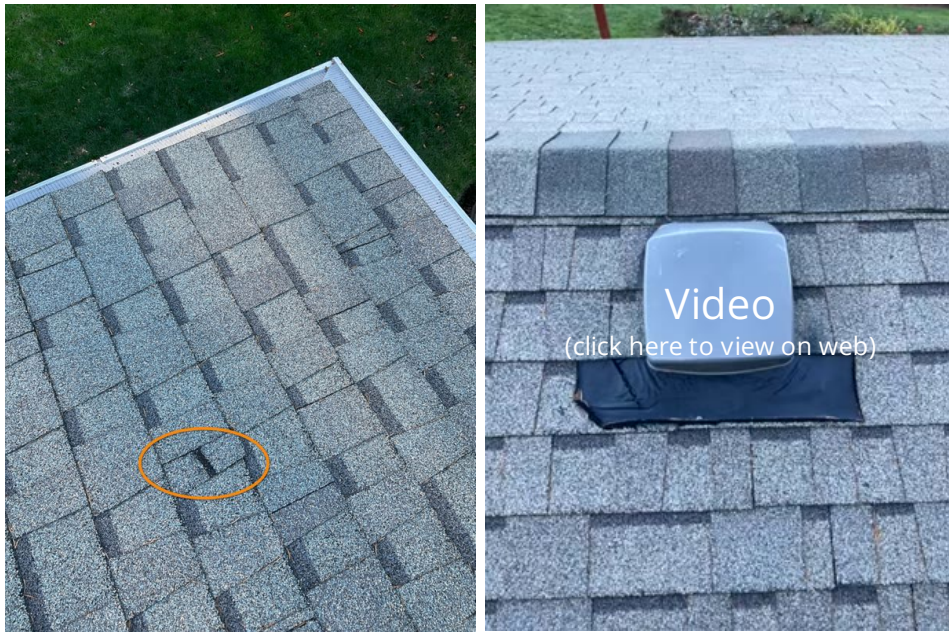
2.1.4 Roof Covering

I observed areas of cracked/splitting and damaged roof-covering materials. This is a major defect. Prone to water leaking into the house. I recommend a qualified roofing contractor further evaluate and make repairs to the roof system as they deem appropriate.

Contact a qualified roofing professional.

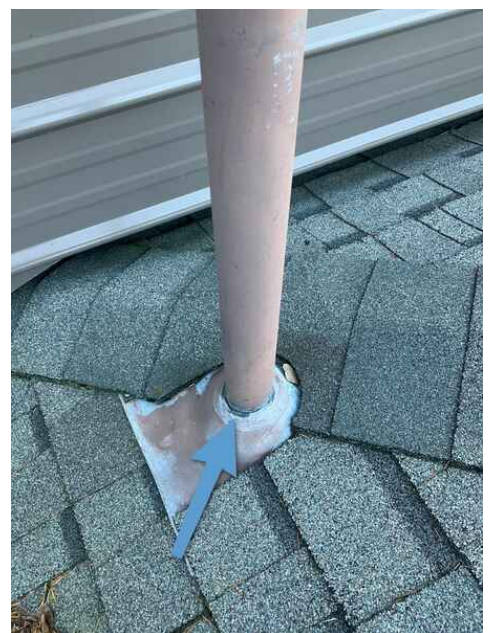
The electrical service mast boot was not sealed to the mast. This should be sealed to prevent leaks.

Contact a qualified roofing professional.

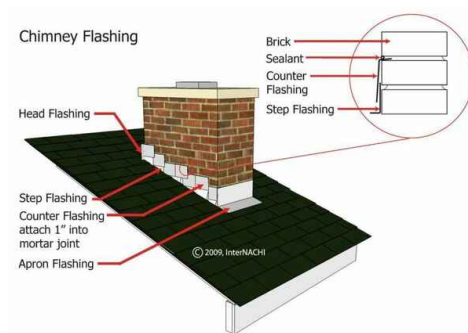
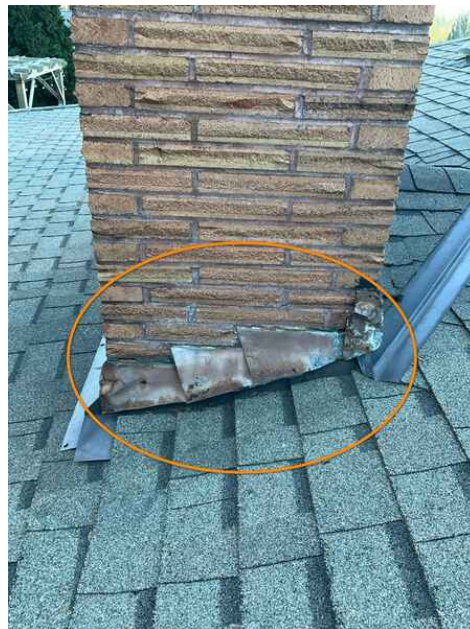
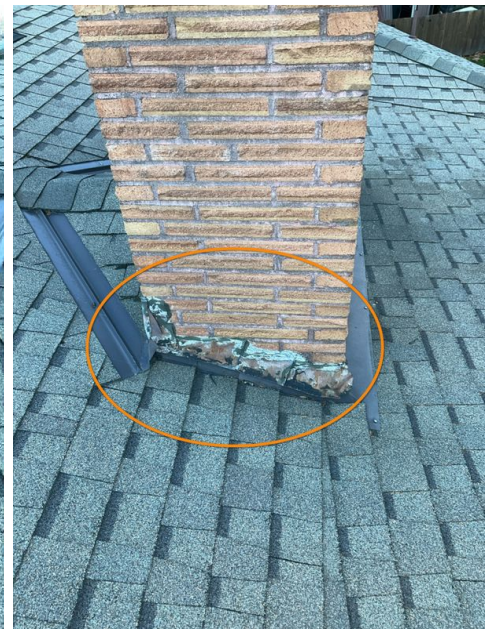
I observed a defect in the chimney flashing. Chimney flashing is prone to leaking water when the flashing/installation is defective.

- I observed step flashing and counter flashing at the chimney, which is good. I recommend, at a minimum, painting the rusty counter flashing to preserve its remaining functional life.

Contact a qualified chimney contractor.

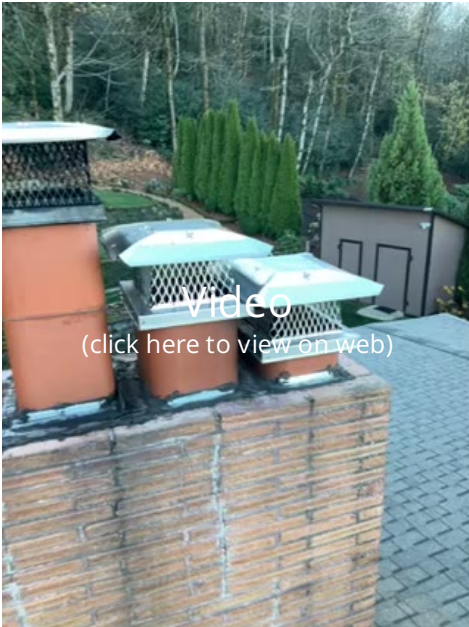
## 2.2.2 Masonry Chimney

I observed a missing chimney rain cap.

Contact a qualified chimney contractor.

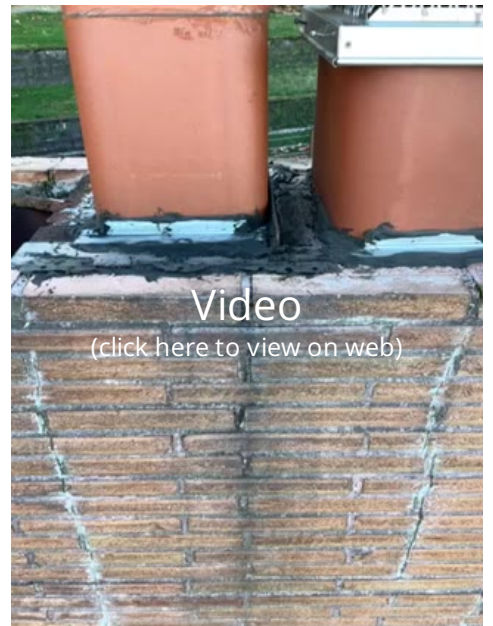
2.2.3 Masonry Chimney

Chimney crown/cap is non-existent. Ask the homeowner about defects and leaks related to the chimney. The sealant and crown flashing was not done by a pro. Ask about why the fourth flue exists and is stuffed with bricks.

If a wash, or crown, on top of the chimney is not properly sloped or is extensively cracked, defective, spalled, or displays rust stains, it should be replaced. Sheet metal caps/crowns with minor rust or corrosion should be repaired, but if rust or corrosion is extensive, replacement is recommended.

Contact a qualified chimney contractor.

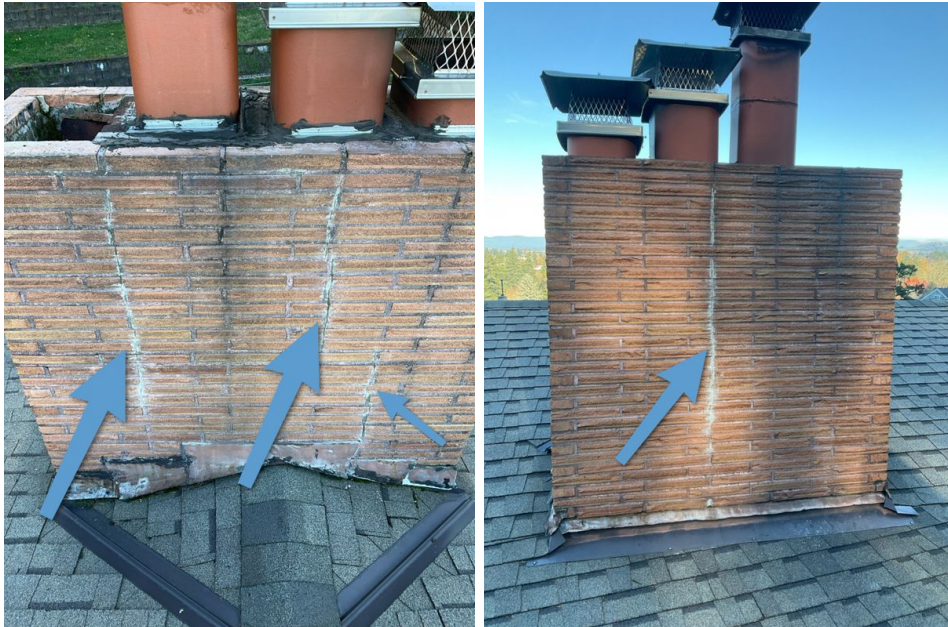
2.2.4 Masonry Chimney

I observed repaired chimney masonry cracks. Homeowner may be able to shed more light.

Contact a qualified professional.

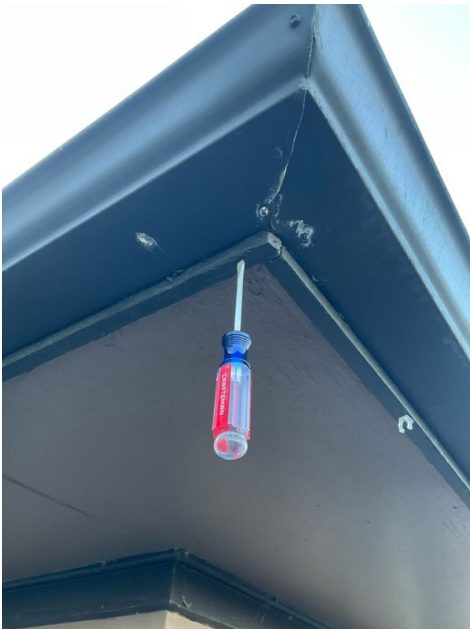
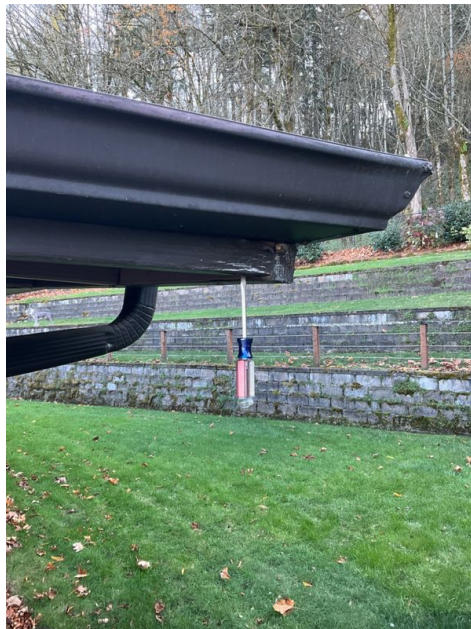
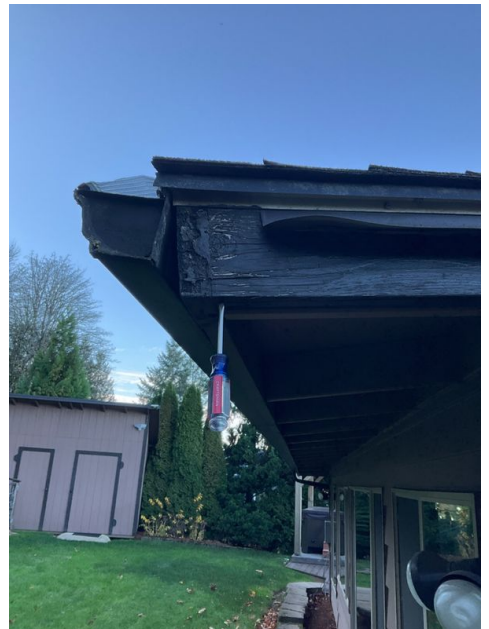
3.2.2 Eaves, Soffits & Fascia

I observed indications that one or more areas of the soffit were damaged. Correction and further evaluation is recommended.

Contact a qualified roofing professional.

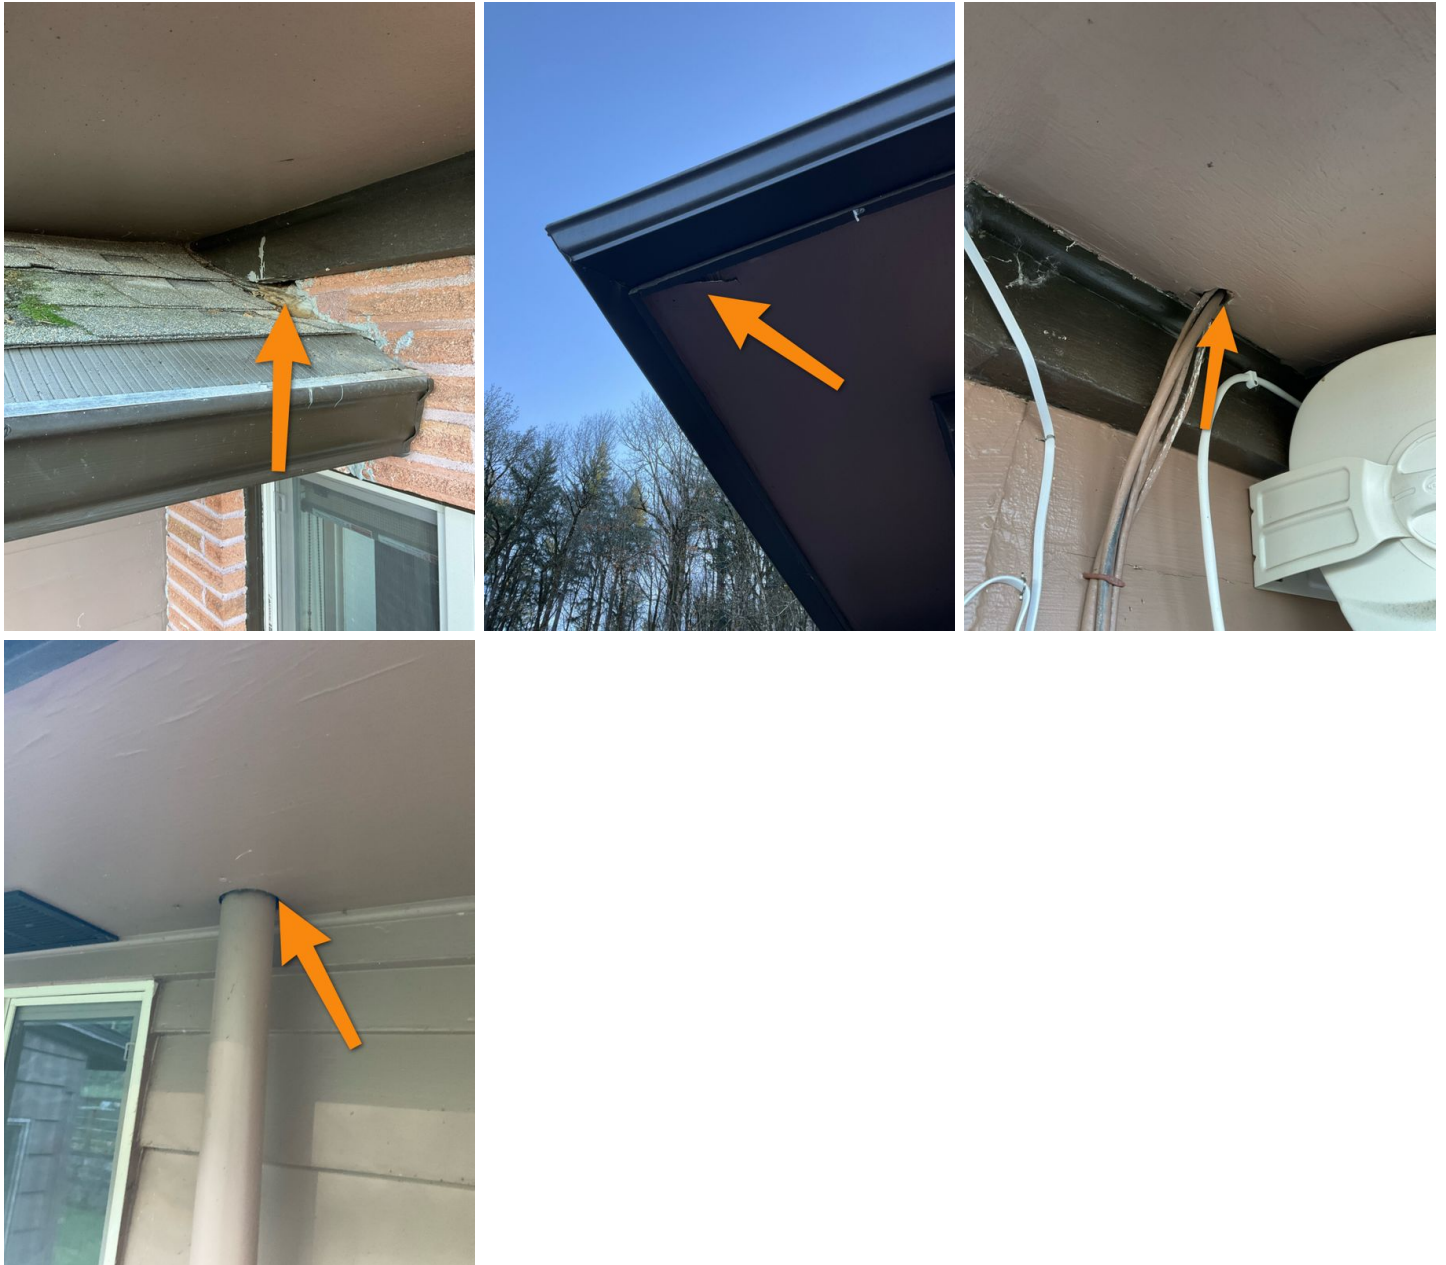
### 3.3.1 Wall-Covering, Flashing & Trim

I observed indications of a defect at the exterior wall-covering material. Correction and further evaluation is recommended. There are various areas of paint peeling, damage, or unconventional siding installation practices. I recommend further evaluation by a siding contractor.

Contact a qualified siding specialist.

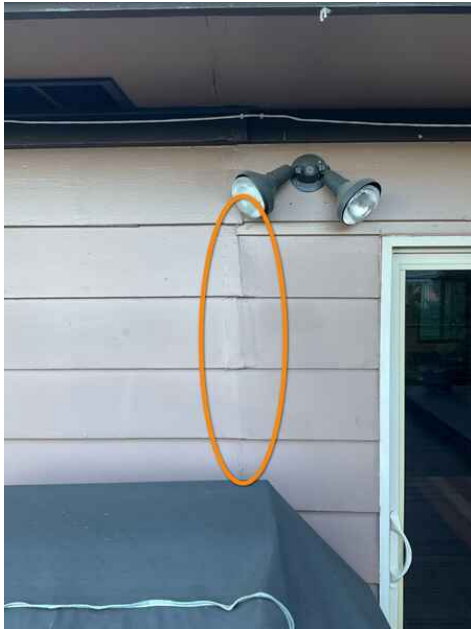
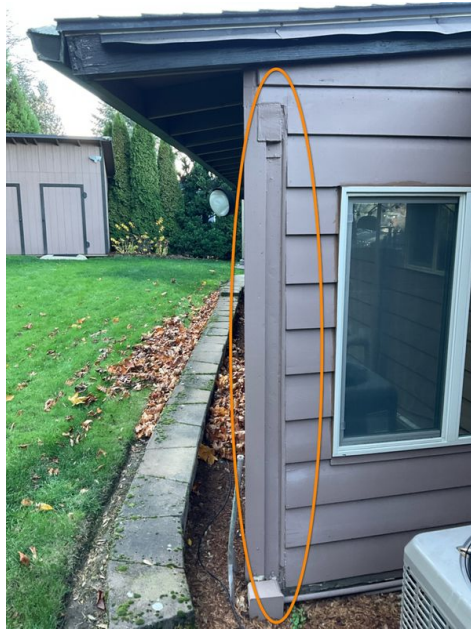
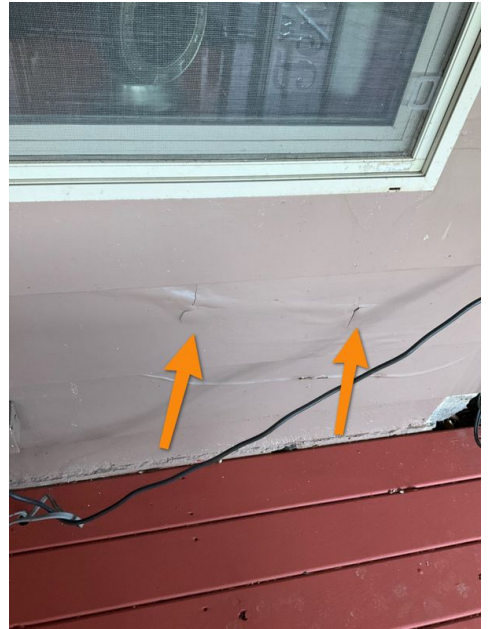
3.3.2 Wall-Covering, Flashing & Trim

Caulking showed cracking in one or more places. Recommend monitoring and repairing as needed.

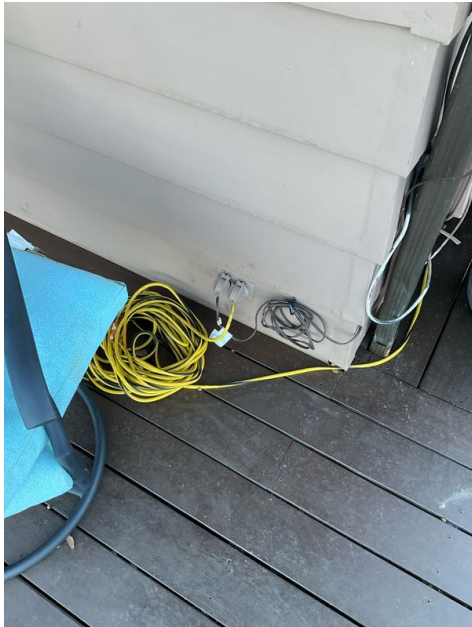
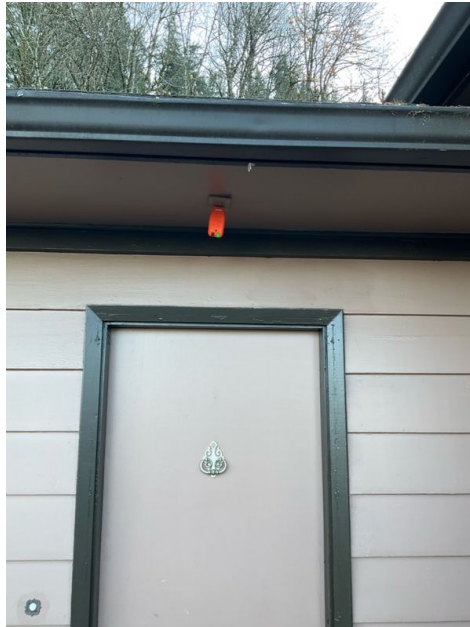
### 3.5.2 GFCIs & Electrical

I observed indications of an electrical outlet with no power outside.

Contact a qualified electrical contractor.

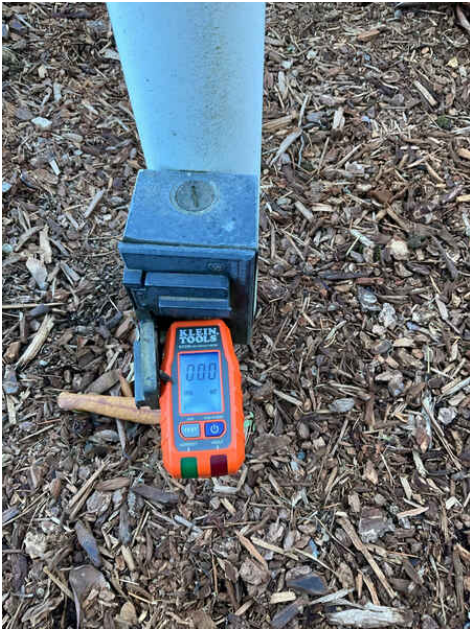
### 3.5.3 GFCIs & Electrical

I observed indications of a major defect during the inspection. Major defect. Hazard. Correction and further evaluation is recommended.

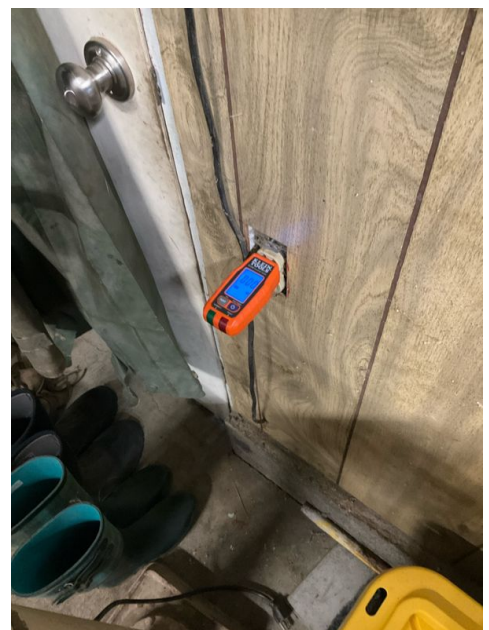
4.4.3 Electric in Garage

I observed loose electrical lines, exposed and unprotected, in the garage. Not professionally installed. Potentially hazardous.
